# **HERITAGE IMPACT STATEMENT**

**WESTERN SYDNEY  
UNIVERSITY  
BANKSTOWN CITY  
CAMPUS**

**74 RICKARD ROAD,  
BANKSTOWN**

**URBIS**

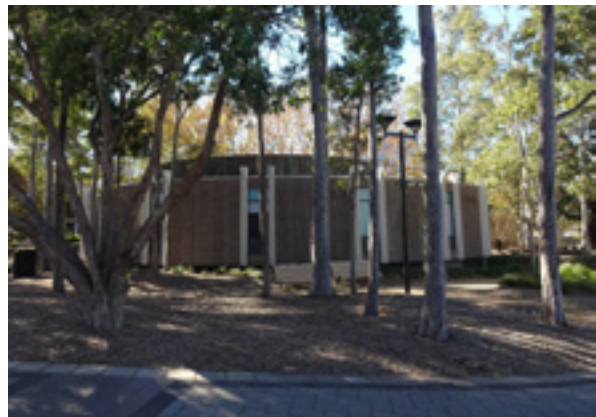
Figure 18 – View towards side elevation of Council Chambers.

The building has a concrete floor slab that sits on piers supported on radial beams framing into a circumferential beam. The roof framing too is a complex of radial rigid frames of steel, supported horizontally at two levels against ring beams eccentric to each other. The lower ring beam of reinforced concrete is supported by steel columns. The external walls are clad with precast exposed aggregate panels. Precast columns at regular intervals frame aluminium framed windows. The columns also house the down pipes. The roof is shallow or flat with a central raised shallow drum. Located off centre of the circle form is the domed skylight. The overall roof form is clad in ribbed copper roof sheets with lapped and folded ribs.

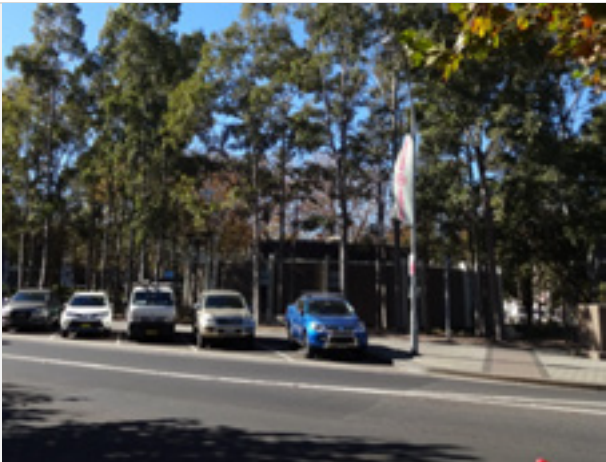
| View | Significance and Impact | Image |
|---|---|---|
| 1 | This is the most encompassing view of the heritage item from the street. The proposed tower would be visible behind the item in this view however would not obscure the view. Note that other buildings are visible in the background behind the heritage item. | <p>View towards the heritage item from the south west.</p> |

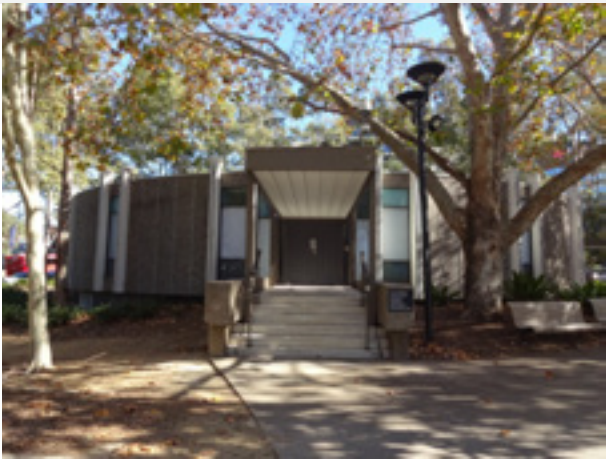
| View | Significance and Impact | Image |
|---|---|---|
| 2 | This is the most encompassing view of the entrance to the heritage item. The proposed tower would be visible behind the item in this view however would not obscure the view. Note that other buildings are visible in the background behind the heritage item. | <p>View towards the heritage item from the south west.</p> |

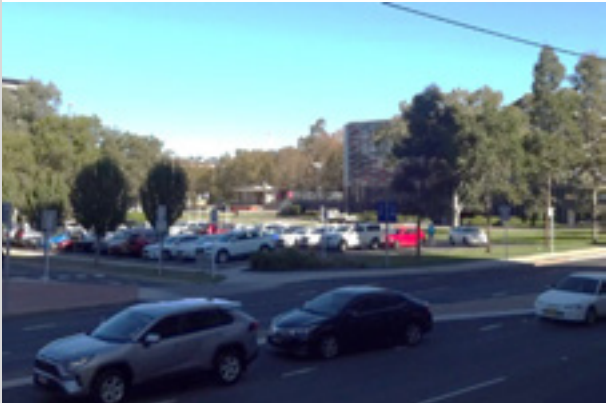
| View | Significance and Impact | Image |
|---|---|---|
| 3 | Views from Rickard Road to the heritage item are currently obscured by the contemporary eastern extension to the Bankstown Town Hall, the utilities building to the west of Paul Keating Park and the mature landscaping around the Council Chambers. It is not considered that this is a significant heritage view. | <p>View towards the heritage item from the north east (Rickard Road).</p> |

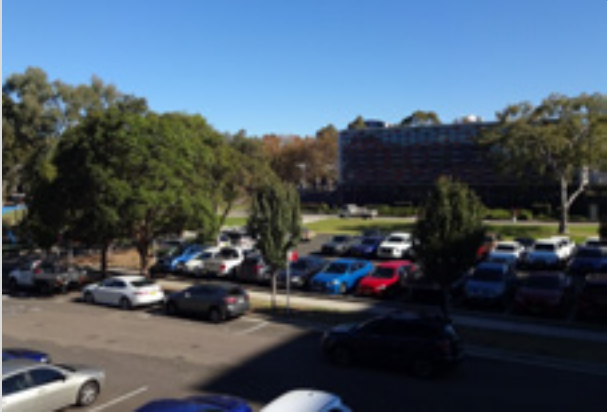
| View | Significance and Impact | Image |
|---|---|---|
| 4 | Views from the raised landing outside 68 Rickard Road towards the heritage item are currently obscured by the utilities building to the west of Paul Keating Park and the mature landscaping around the Council Chambers. It is not considered that this is a significant heritage view given the view is highly obscured and the viewpoint is from private property. | <p data-bbox="772 638 1444 705">View towards the heritage item from the raised landing outside 68 Rickard Road.</p> |

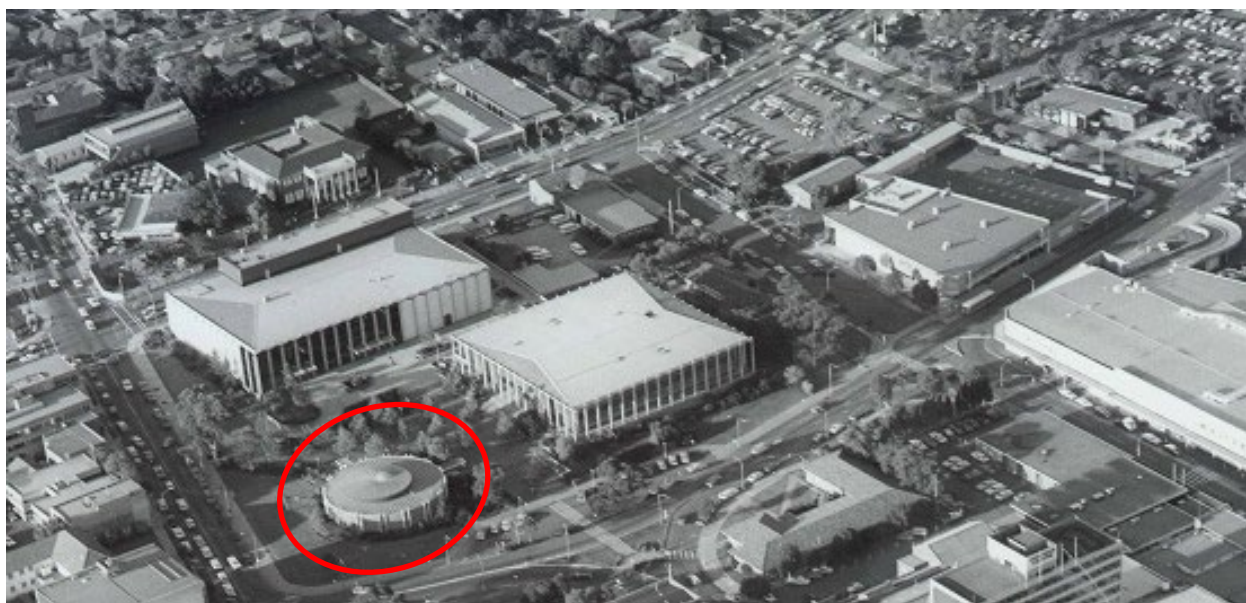
Figure 37 – c1970s oblique aerial photograph showing the historic development surrounding the heritage listed item circled red.

- Although the open space allows a visual curtilage around the Council Chambers, the centre was built at a time where the subject site, and the site immediately to the south were occupied by substantial buildings as shown in the historical overview in Section 3 above in this report. The Council Chambers was designed to have a close physical association with the Administration Building and Town Hall, which it was built concurrently with to implement the three stages of the Civic Precinct. It is noted that the administration was in significantly closer proximity to the listed item than the proposed building. The aesthetic significance of the Council Chambers is therefore not historically vested in the open space to its north east and the development of the subject site as proposed would have no heritage impact.

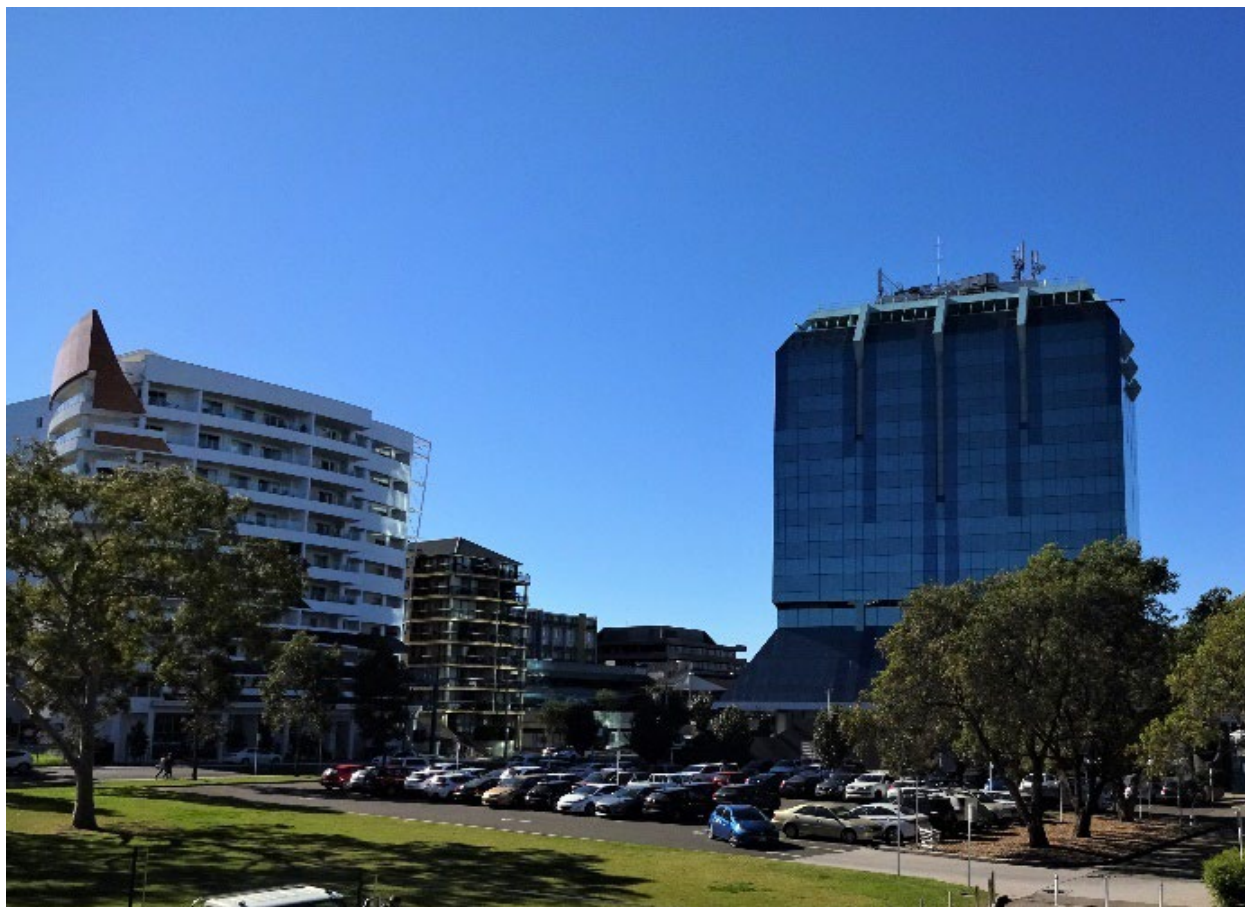
Figure 38 – Existing development visible in the broad context of the Bankstown City Centre.

- The proposed building would be visible to the rear of the Council Chambers when the latter is viewed from the intersection of Chapel Road and The Mall. However, it should be noted that the proposed building is in keeping with the character of the Bankstown City Centre and the character of existing buildings which are also visible from this vantage point (including that at 68 Rickard Road and 75 Rickard Road).

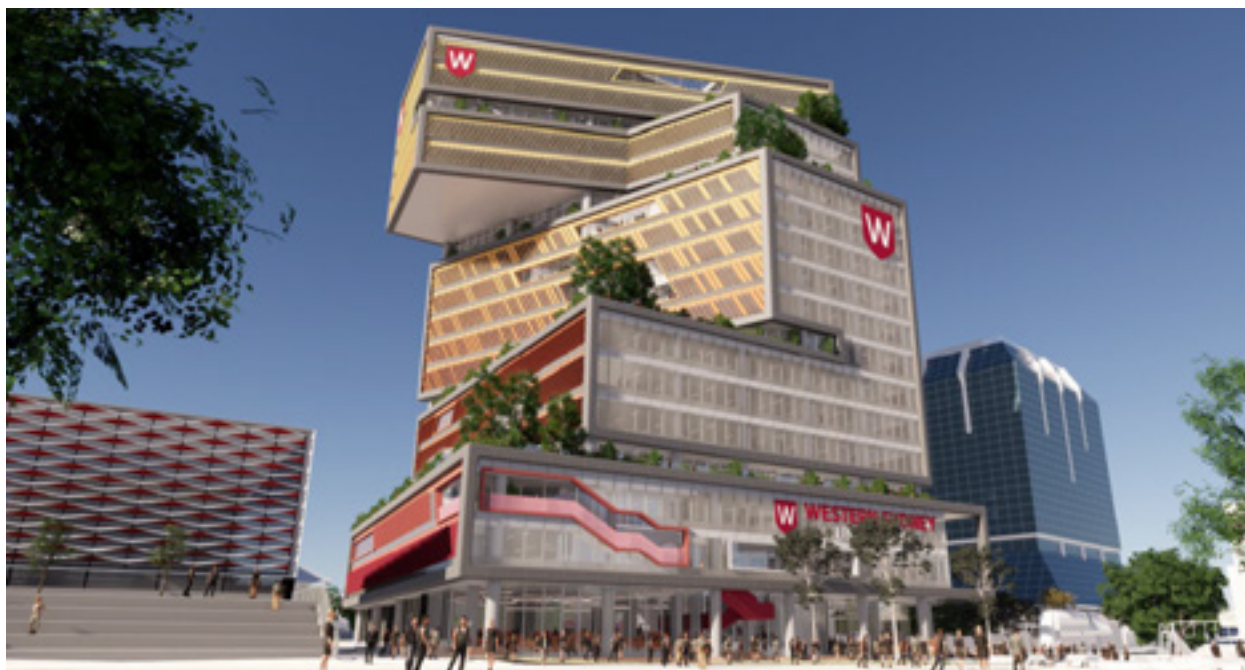
Figure 39 – Render of the south west corner of the proposed building.

- The landscaping on the ground plan is largely confined to the eastern boundary of the site. However, in addition to the above, landscaping has been incorporated throughout the building form which softens the presentation of the building in visual context of the heritage listed item. Substantial outdoors areas are created by the splay of the building forms and mature landscaping would be incorporated into the areas. Landscaping is visible on all four facades of the proposed building.
